# Pike Hill Copper Mine Superfund Site Information Update - January 2022

# Pike Hill Copper Mine

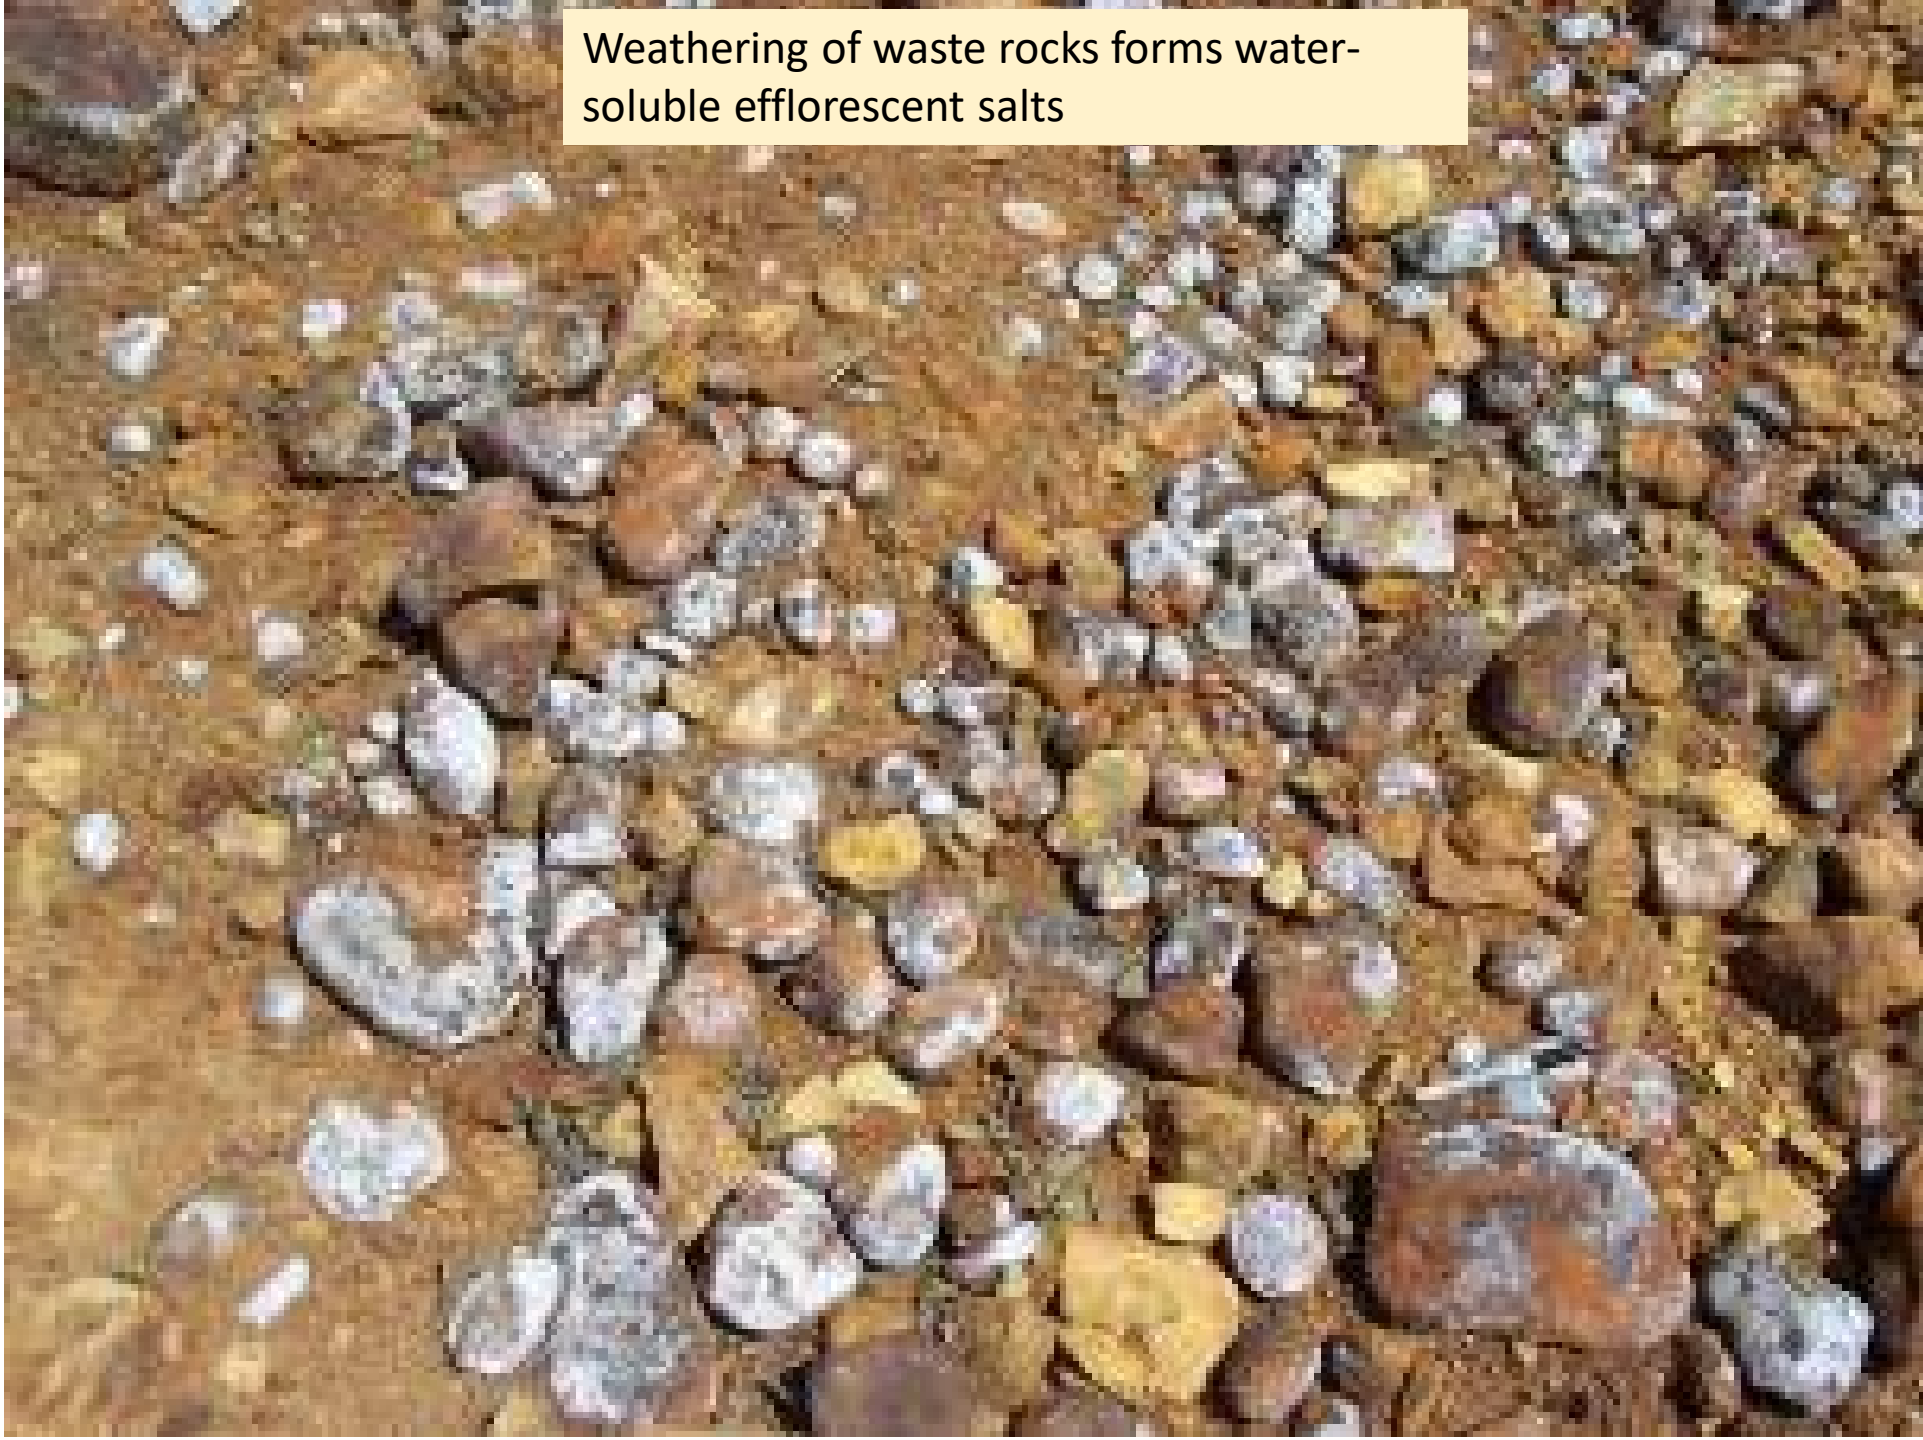
Weathering of waste rocks forms water-soluble efflorescent salts

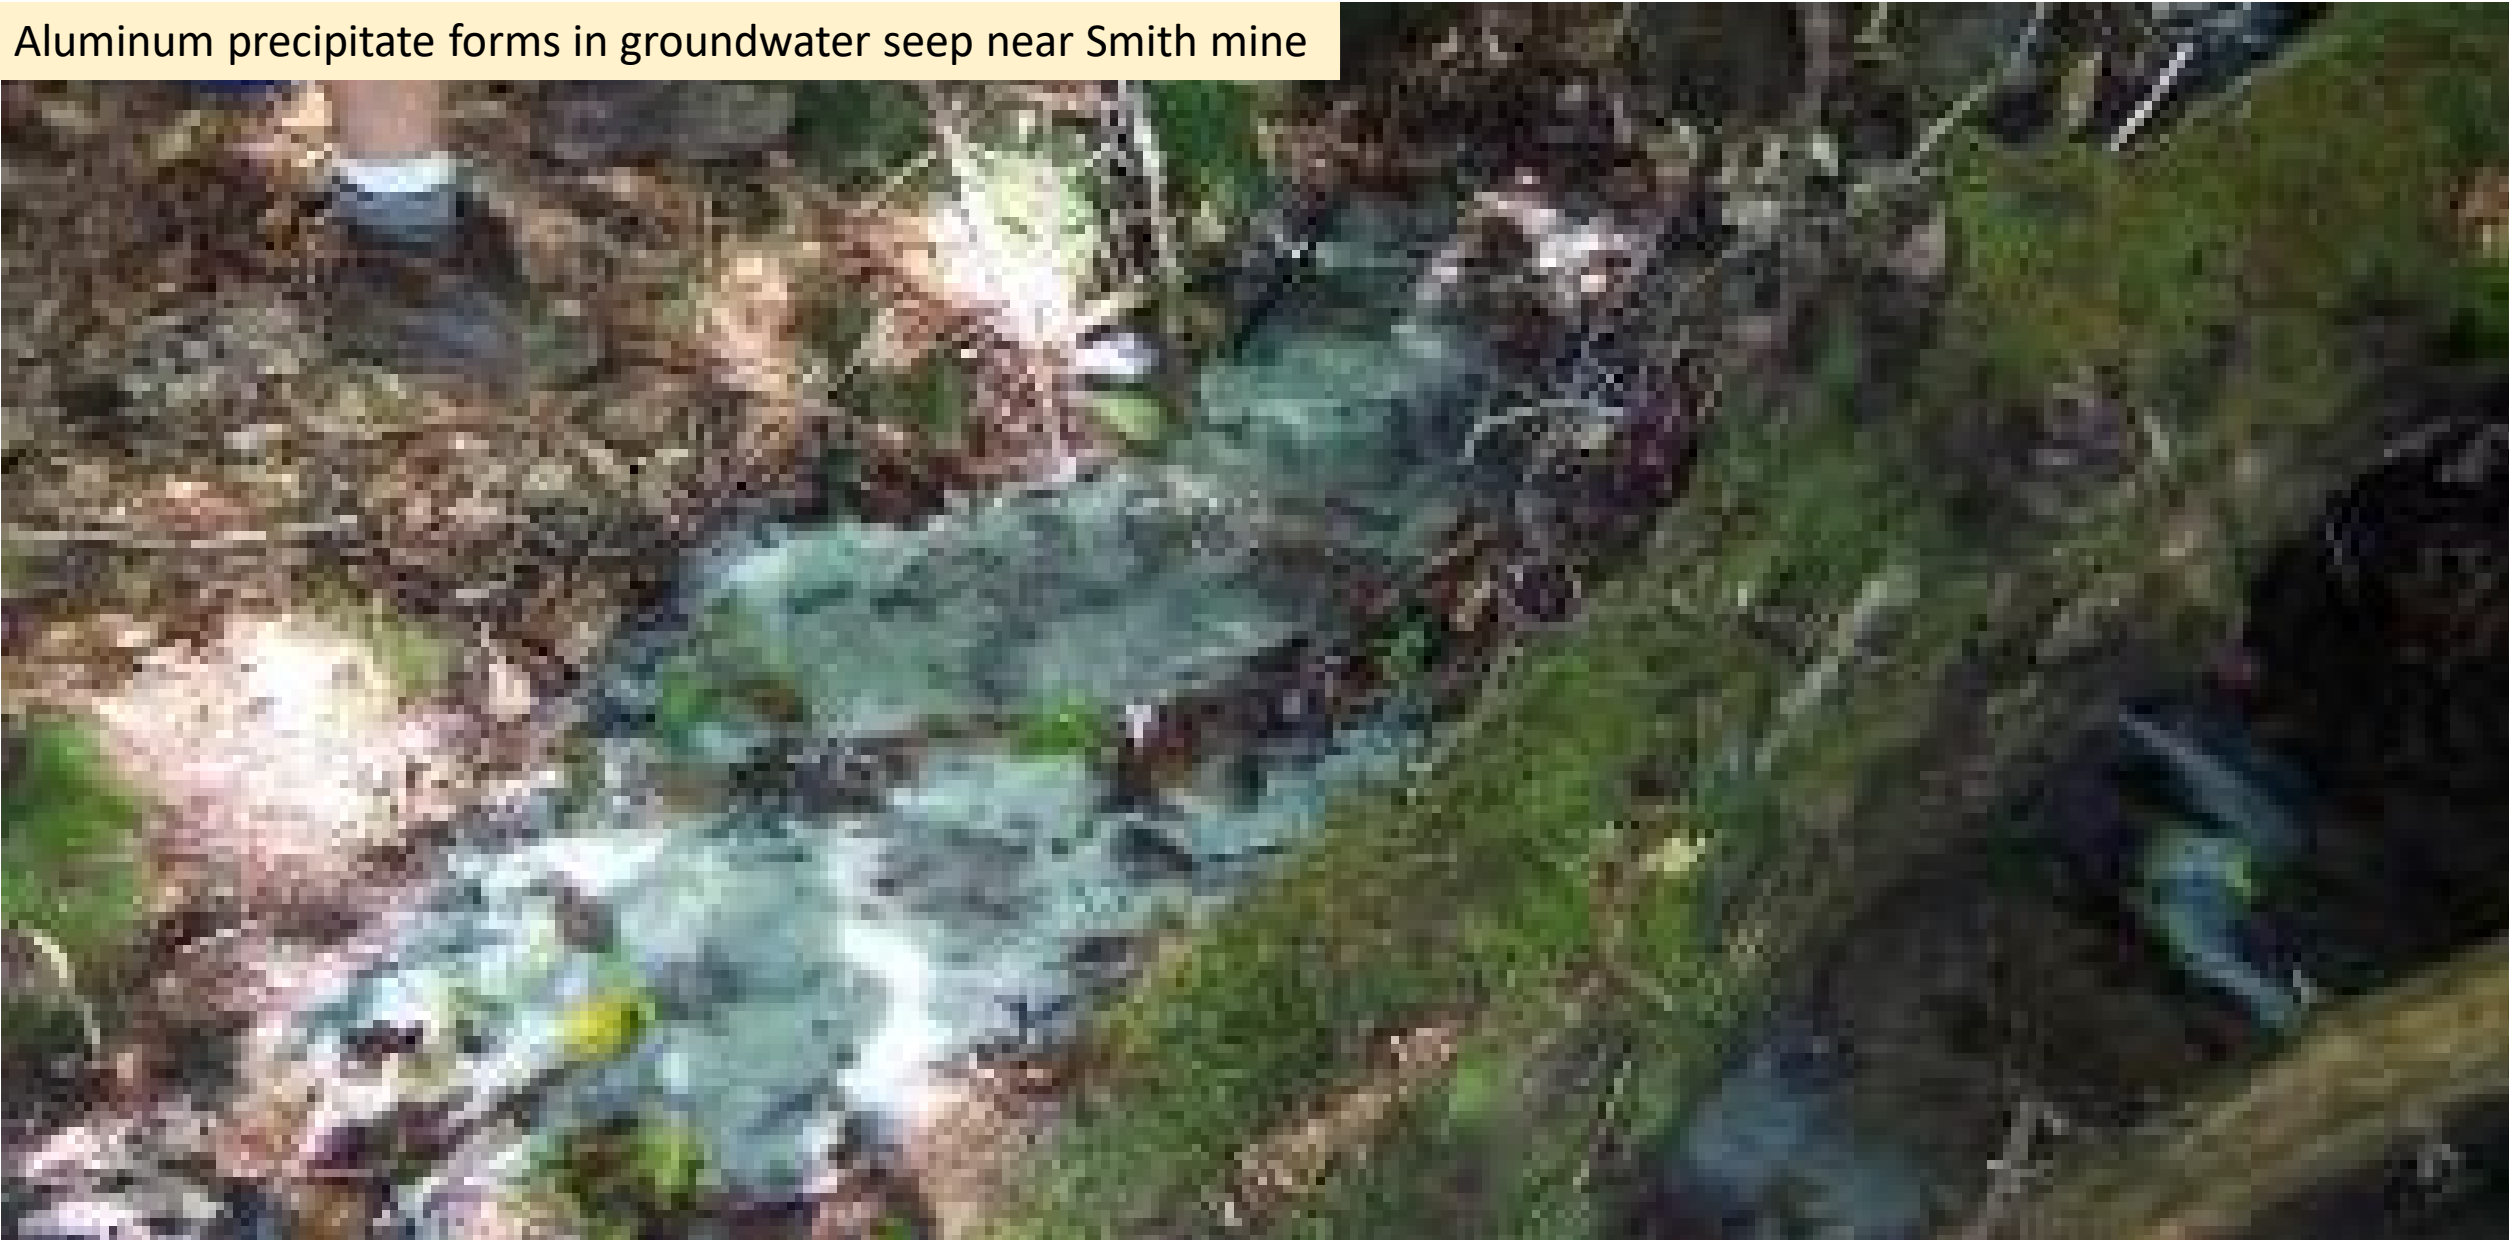
Aluminum precipitate forms in groundwater seep near Smith mine
